CALSPAN ON-SITE AIR BAG DEPLOYMENT INVESTIGATION

CALSPAN CASE NO. 91-14

FLEET - 1992 PLYMOUTH ACCLAIM

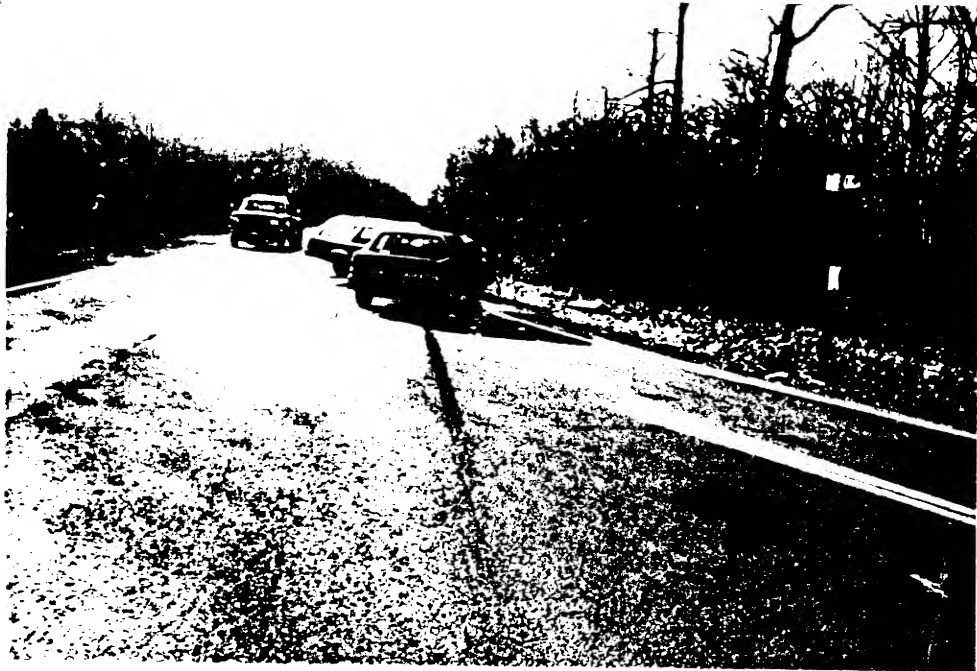
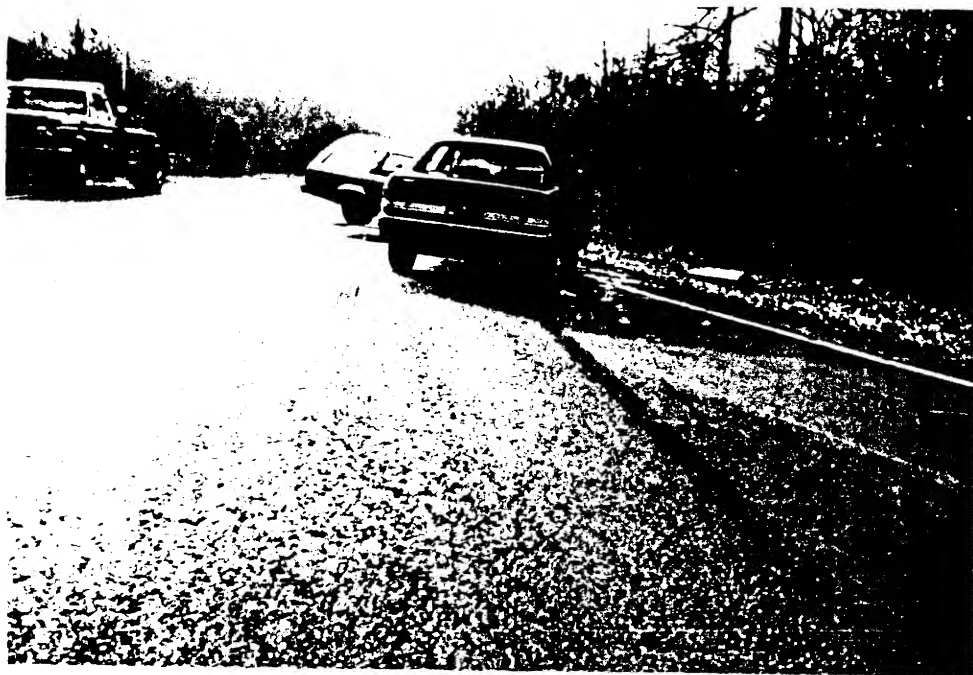
Pre-Impact Skidding Of The Plymouth And Final Rest Positions
Of The Involved Vehicles.

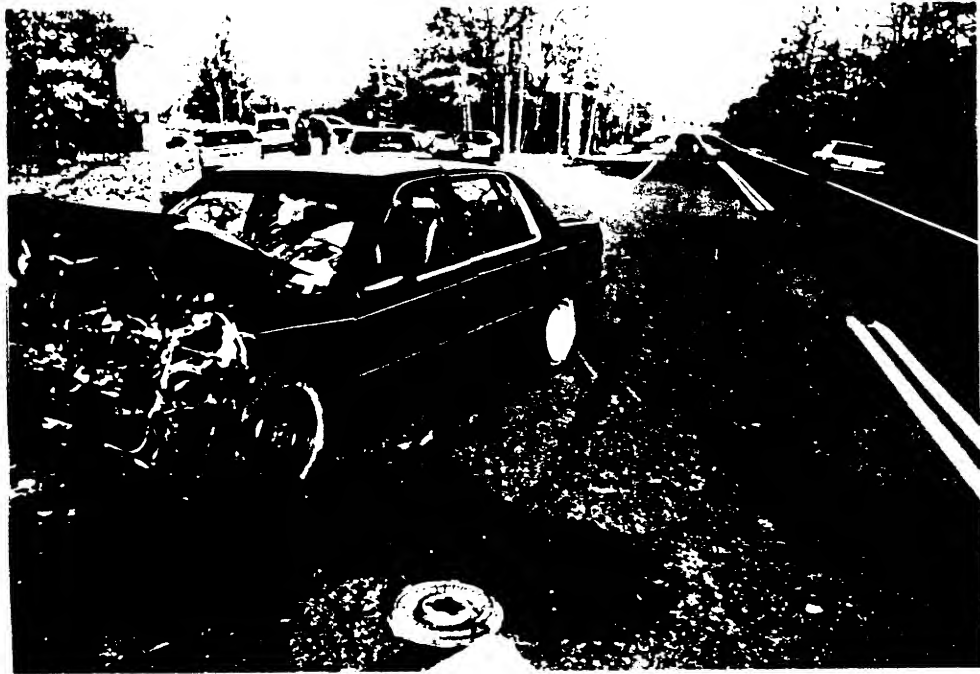
Lateral Displacement Of The Plymouth Acclaim.

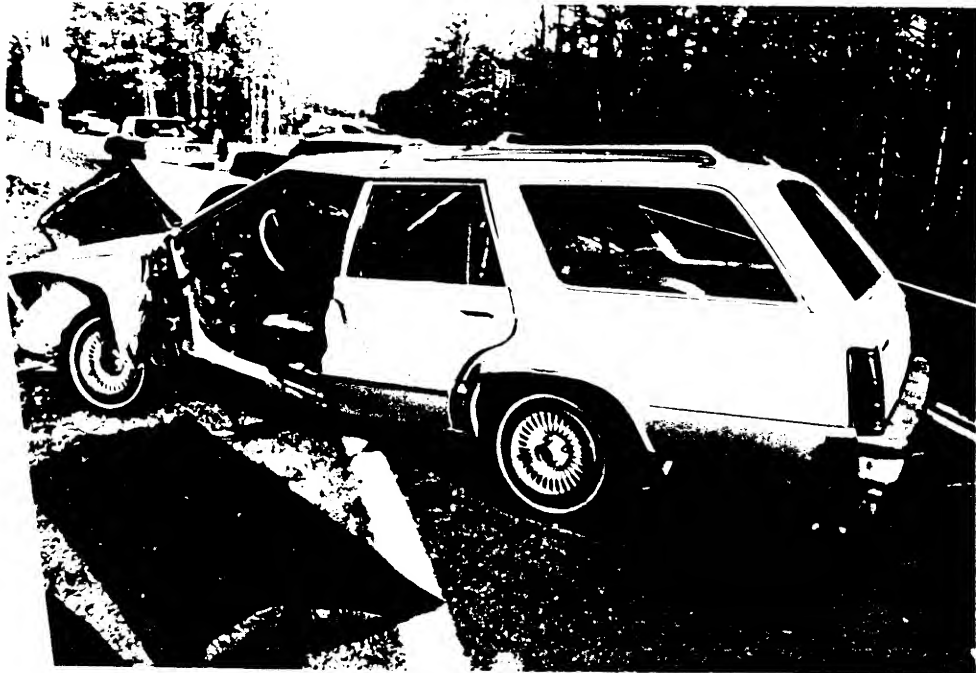
Impact Induced Displacement Of The Mercury Zephyr.

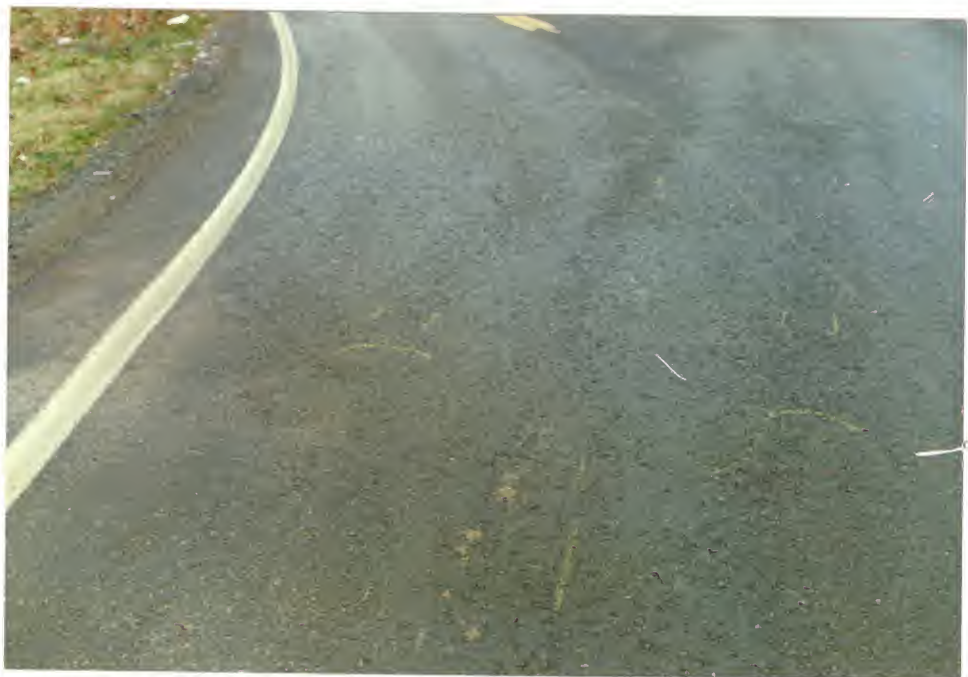
Point Of Impact, Deflection Of The Acclaim's Skid Marks.

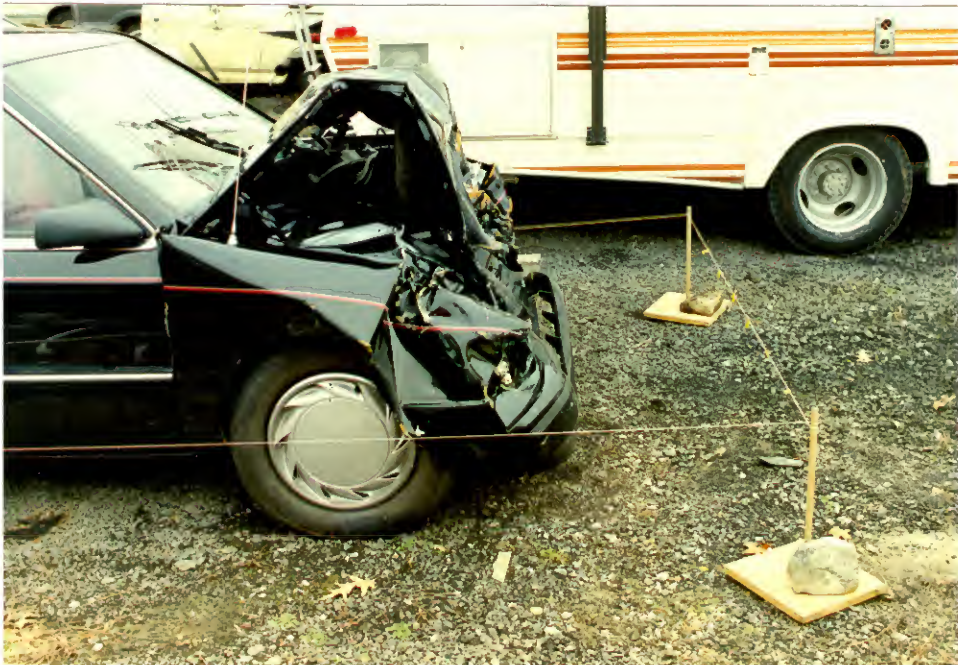
Perpendicular View Of The Right Frontal Area Showing The Extent of Crush.

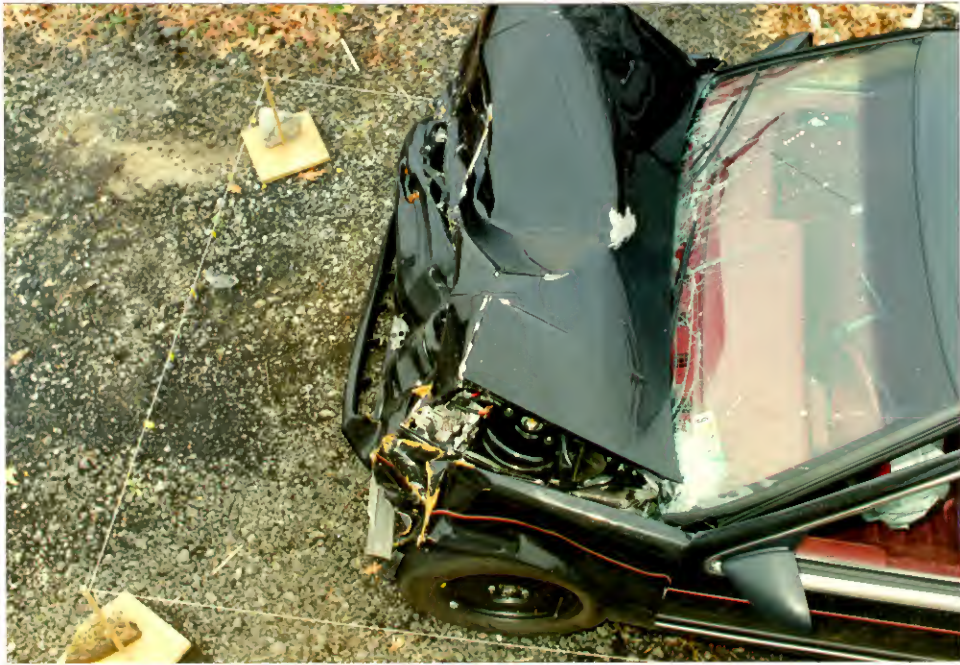
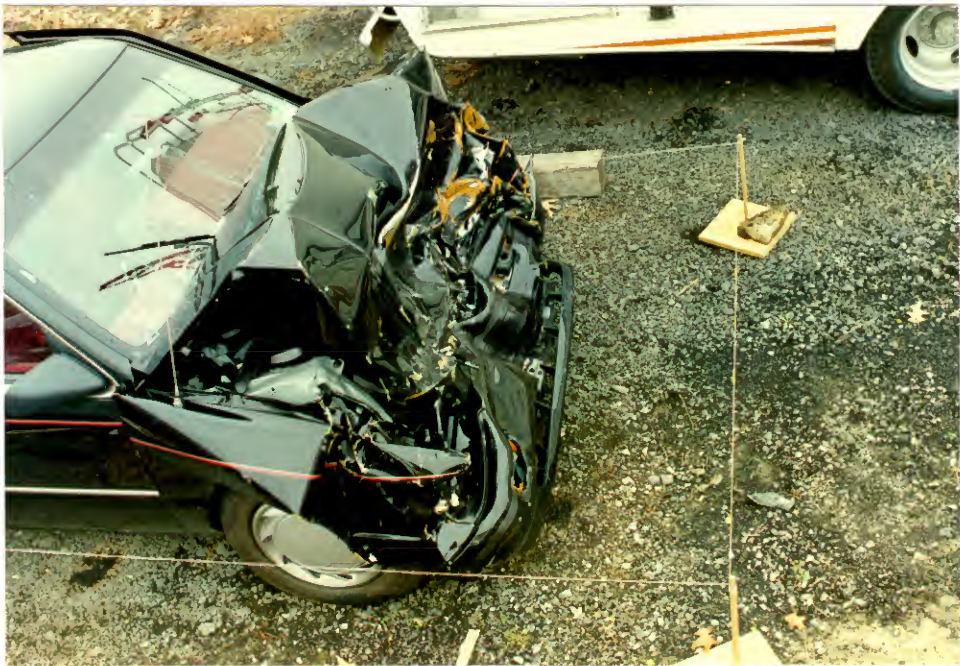
Overhead Views Showing The Extent of Frontal Crush.

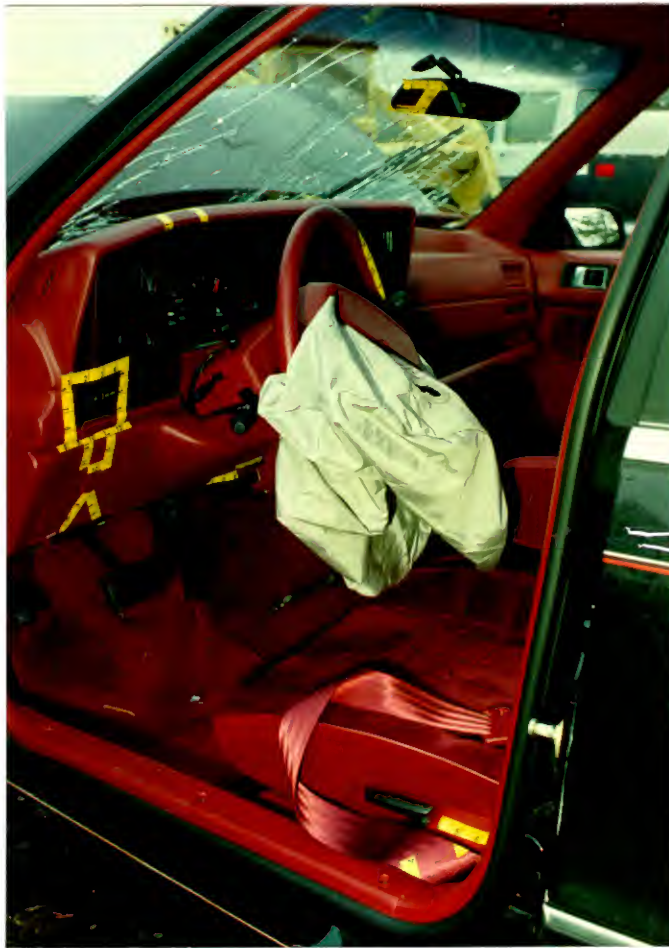
Overall Interior View Of The Deployed Air Bag And Occupant Contact Points.

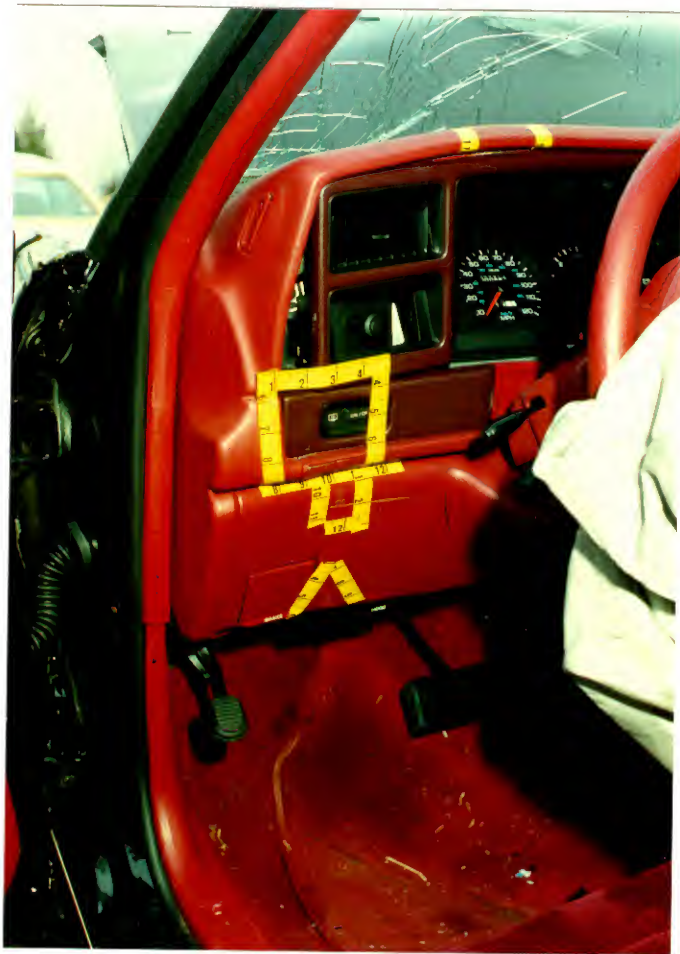
The driver's left knee impacted the left mid instrument panel adjacent to the backlight defroster switch. The contact cracked the plastic panel and deposited blue fabric transfers 20 - 23" left of center. As a result of the contact, he sustained a fractured left patella. The driver's lower left leg contacted the left side of the knee bolster at the fuse box cover. The contact produced blue fabric transfers on the struck component 20.5 - 21.5" left of center and abraded the driver's lower leg. His right knee impacted the knee bolster at the protrusion for the steering column and continued across the bolster into the center instrument panel adjacent to the radio. Abrasions and blue fabric transfers evidenced the contact sequence. As a result of the right knee loading, the driver sustained a ruptured tendon of the knee.

Driver's Left Knee And Leg Contacts To The Mid Instrument Panel and Knee Bolster.

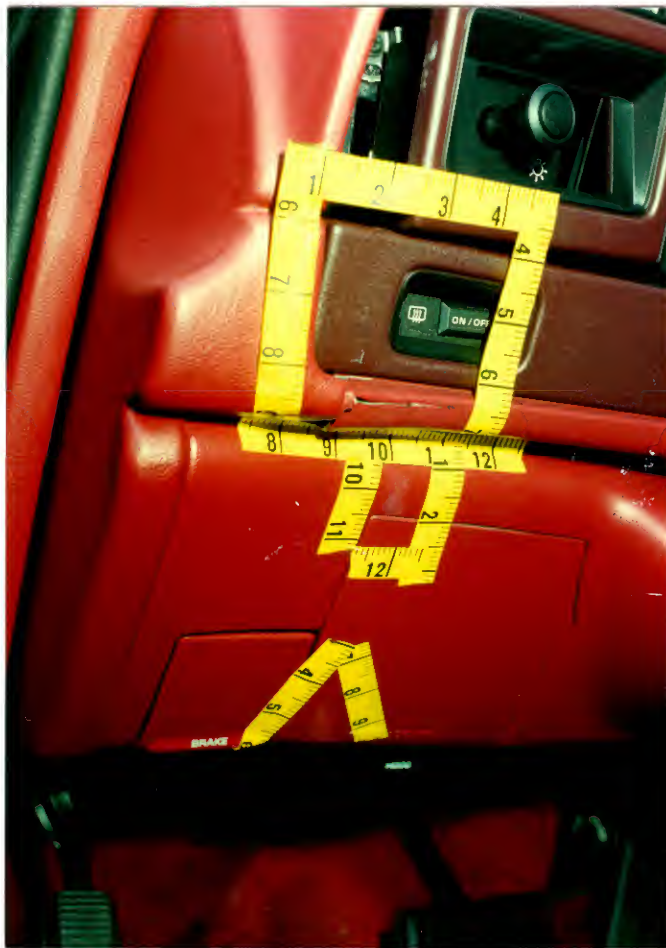
Closeup View Of The Driver's Knee And Leg Contacts.

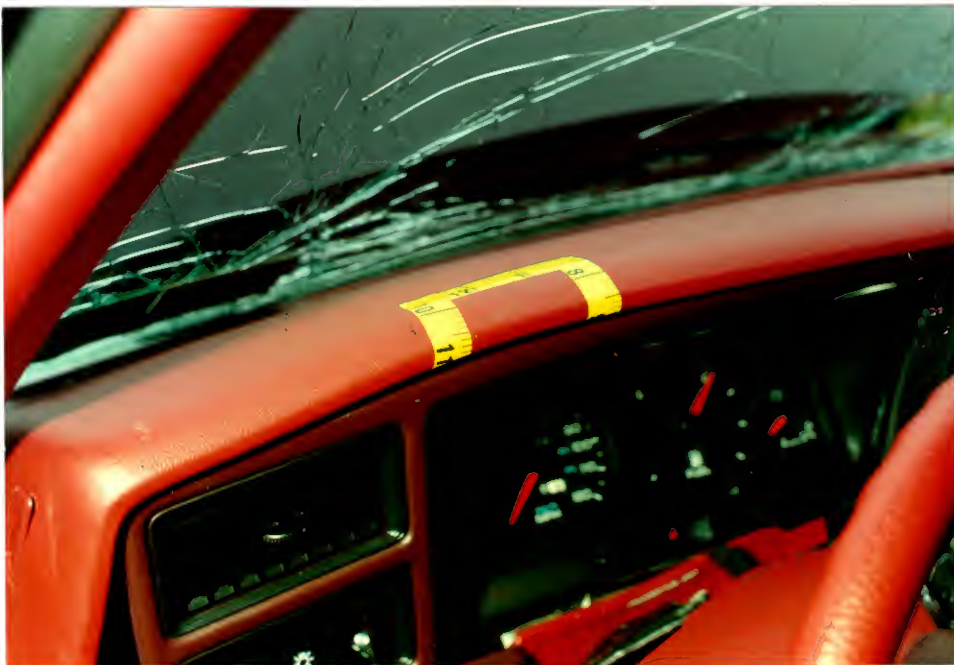
The driver attempted to brace against the steering wheel rim with both hands. His left hand separated from the wheel and impacted the upper instrument panel 16.5 - 18.5" left of center. The contact abraded the panel, compressed the energy absorbing material, and displaced the panel upward. As a result of the contact, the driver sustained a fractured left wrist. His right hand separated from the rim and probably impacted the center instrument panel area (no evidence of contact) which fractured his 4th and 5th metacarpals.

Driver's Left Hand Contact To The Upper Instrument Panel.

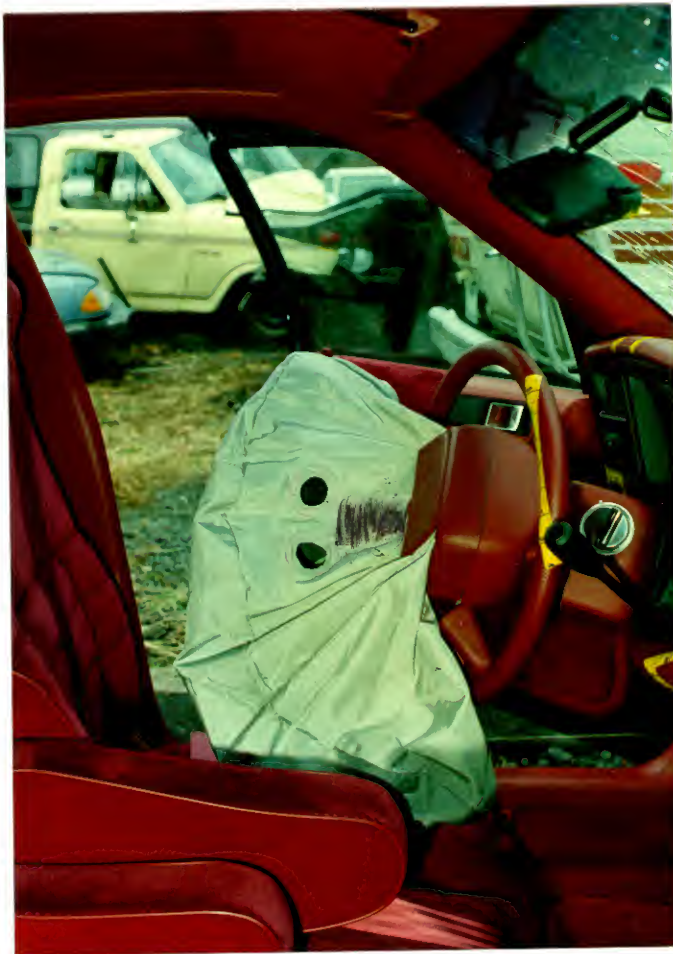
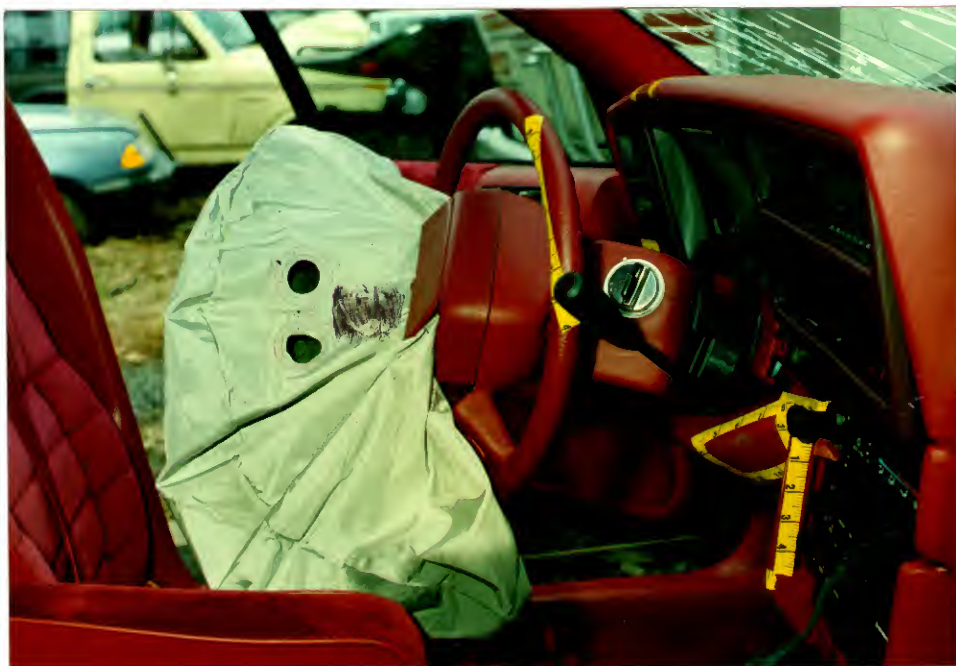
The driver's thoracic area subsequently loaded the deployed air bag with sufficient force to compress the bag against the steering wheel. His loading force was transmitted through the compressed air bag and into the steering assembly which resulted in bending of the steering wheel rim and compression of the energy absorbing steering column (2.5"). As a result of his loading against the active belt webbing and the air bag/steering assembly, the driver sustained four fractured ribs. He rebounded into the left front seat back where he came to rest.

Perpendicular Views Of The Steering Wheel Rim Deformation
That Resulted From Driver Loading.

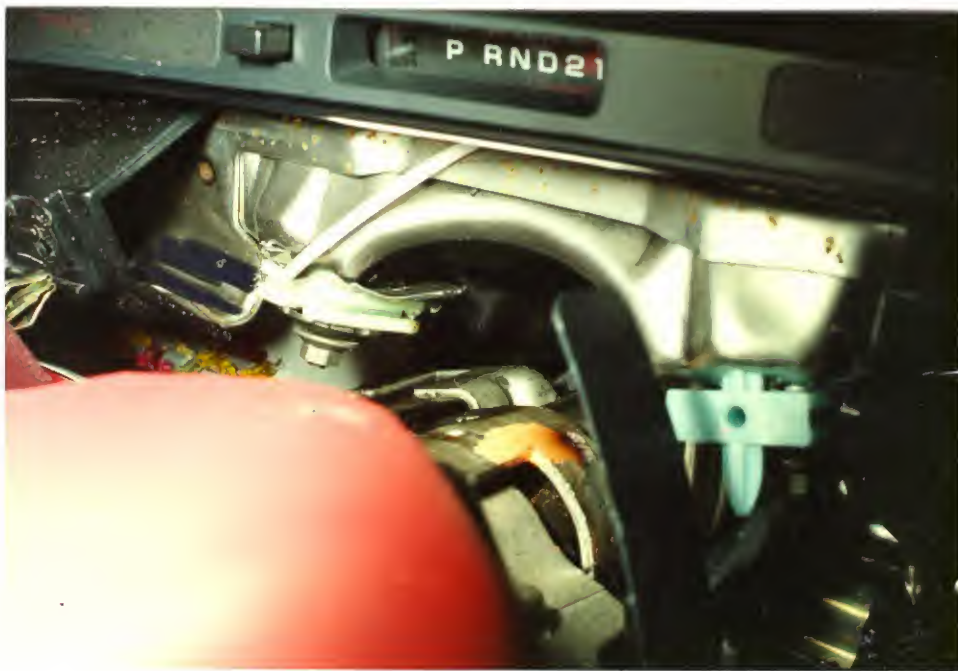
Left Shear Capsule Separation.

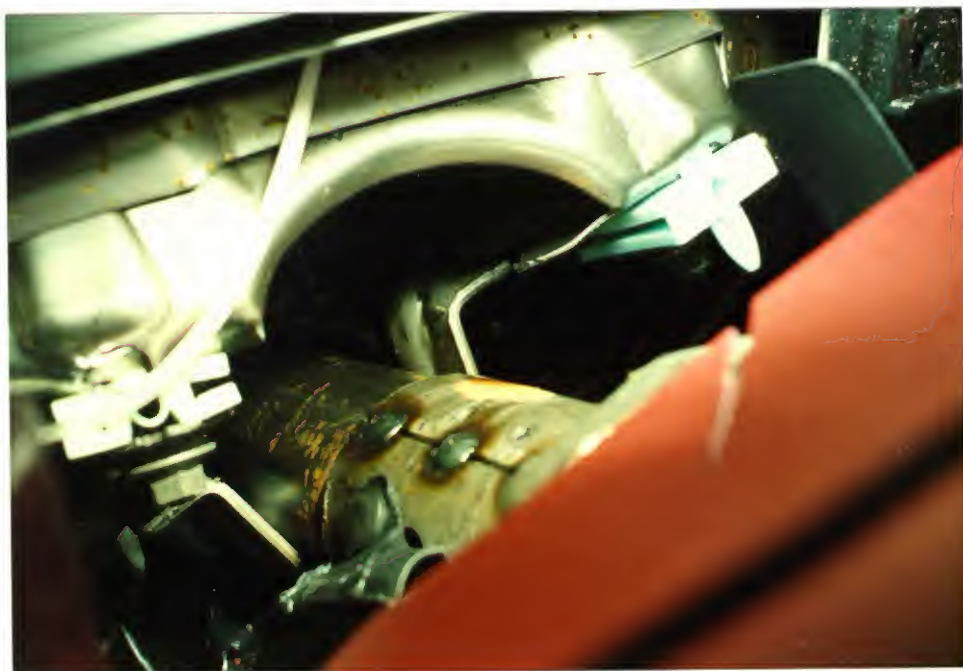
Right Shear Capsule Separation.

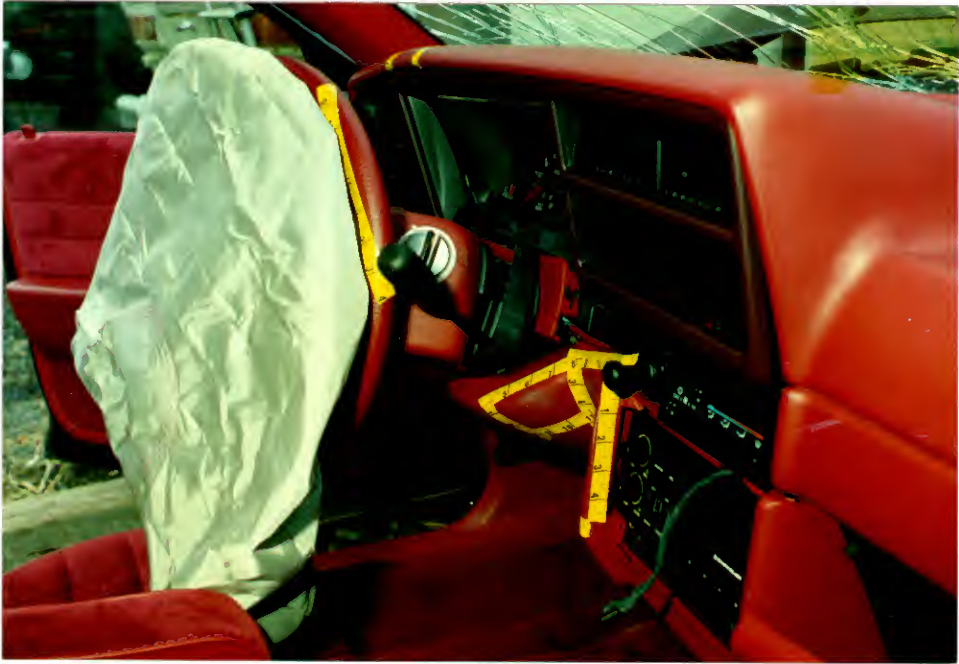
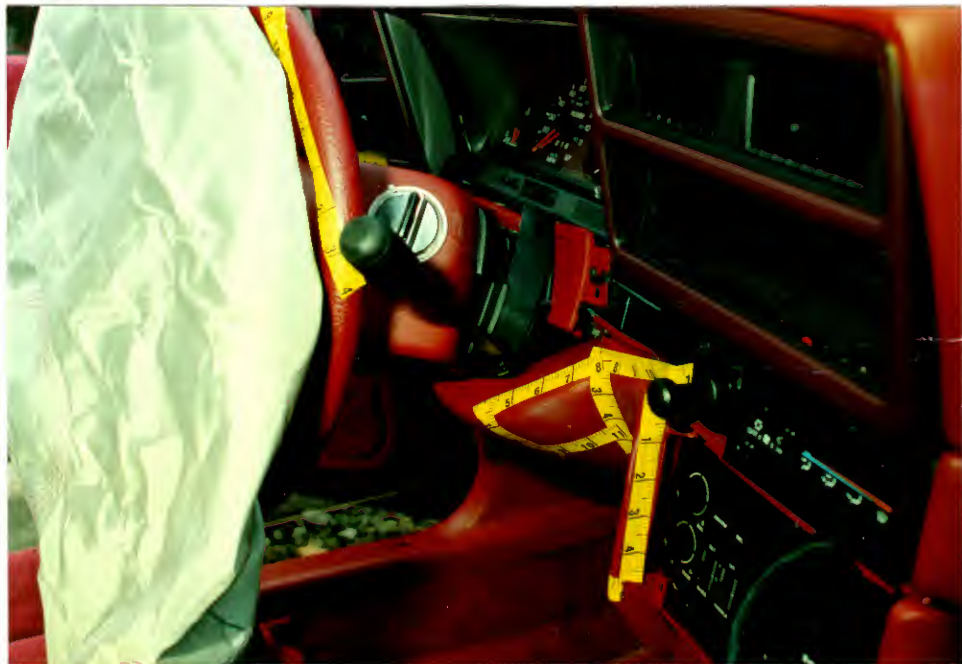
Driver's Right Knee And Leg Contact To The Knee Bolster.

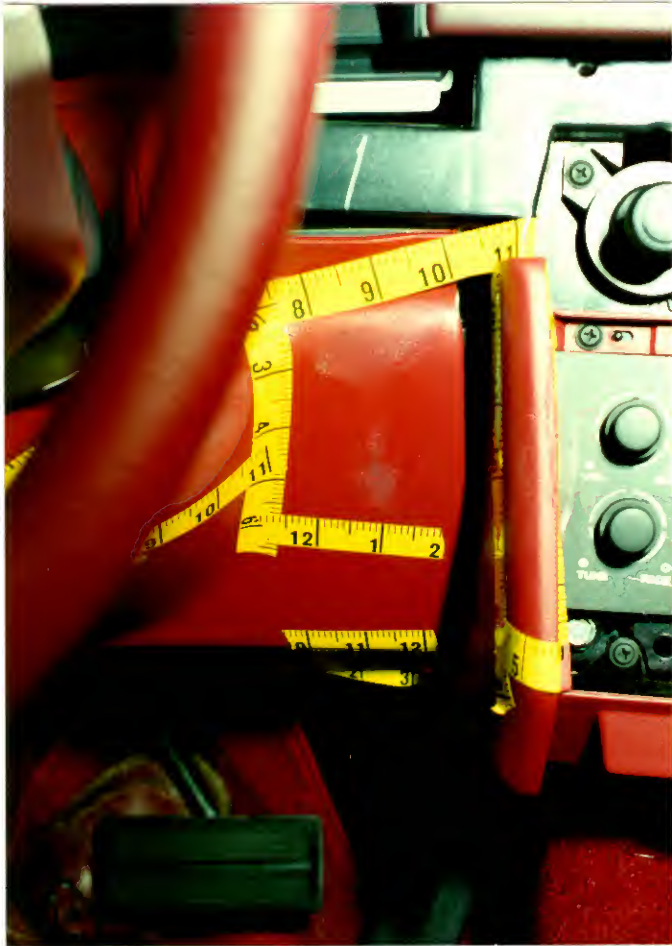
Closeup View Of The Right Knee Contact

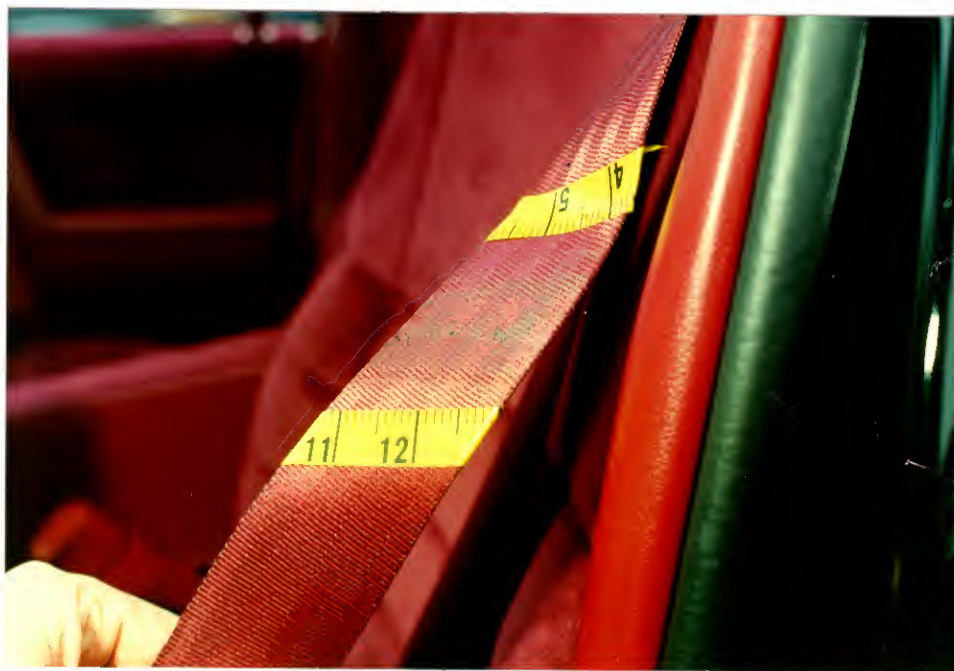
3" Diagonal D-Ring Transfer On The Shoulder Belt Webbing.

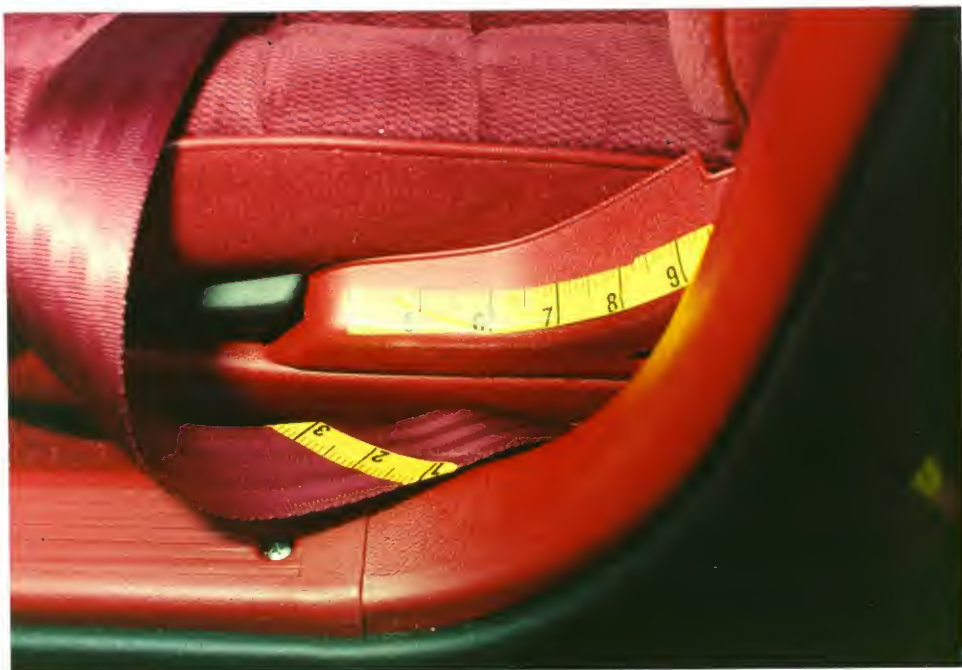
Lap Belt Loading Abrasions To The Plastic Extrusion
At The Left Seatback/Seat Cushion Juncture.

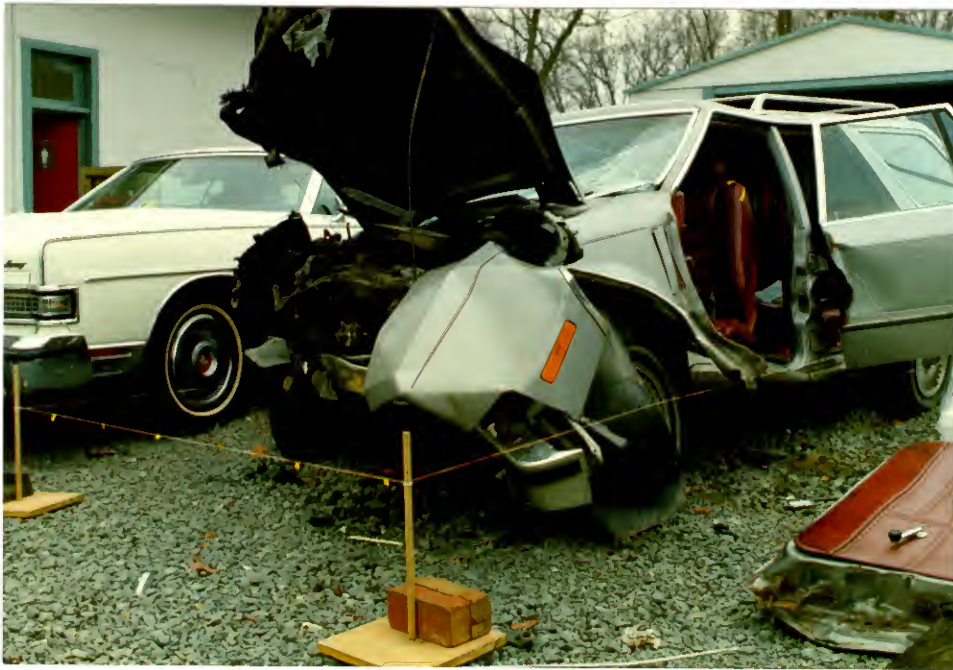
Frontal View Of Vehicle #2.

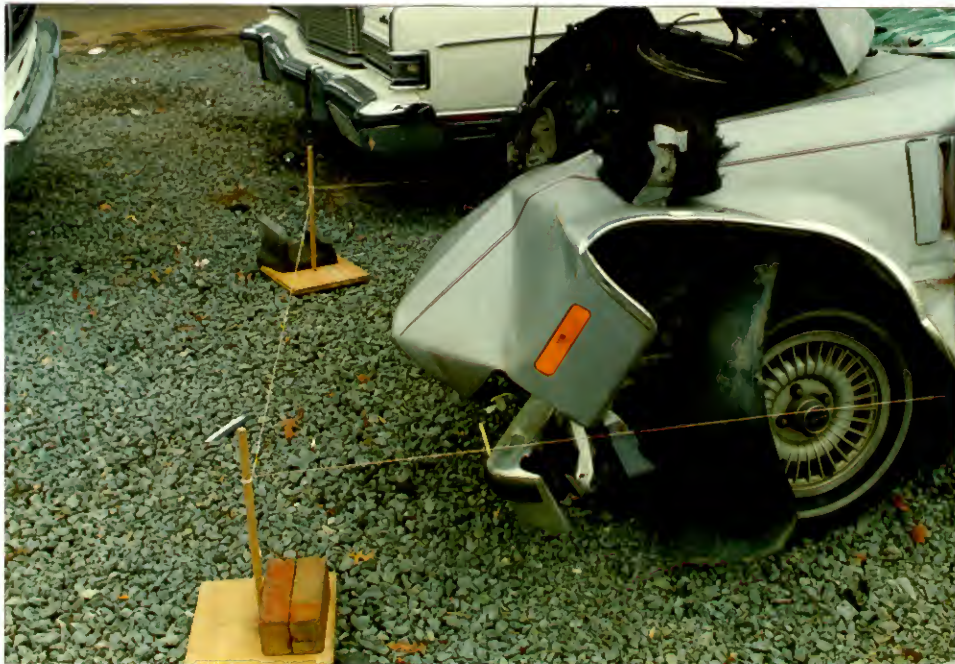
Left Front Three-Quarter View.

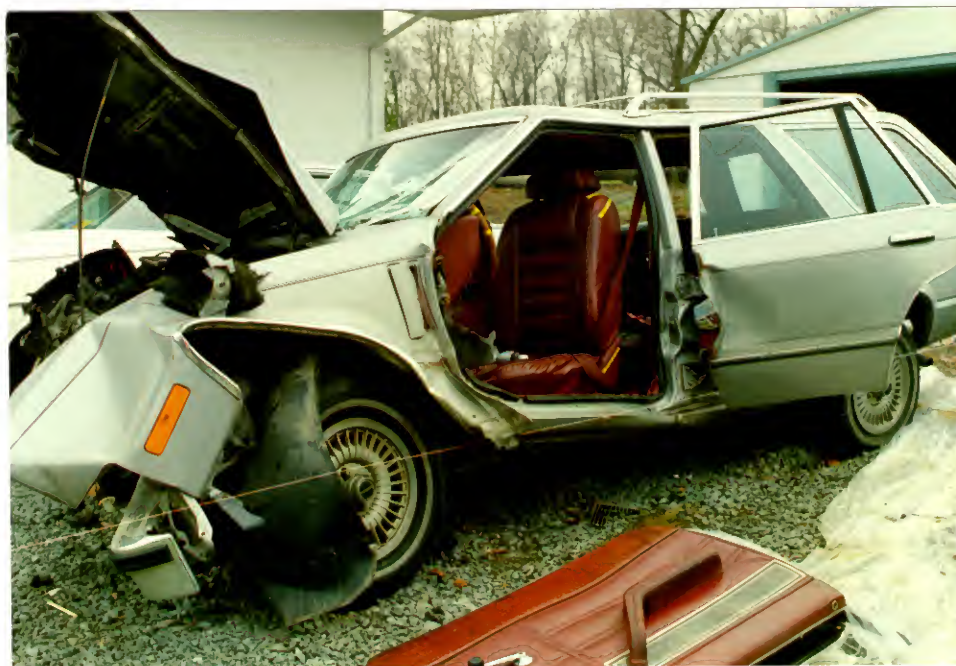
Perpendicular View Of The Left Frontal Area Showing The Extent Of Crush.

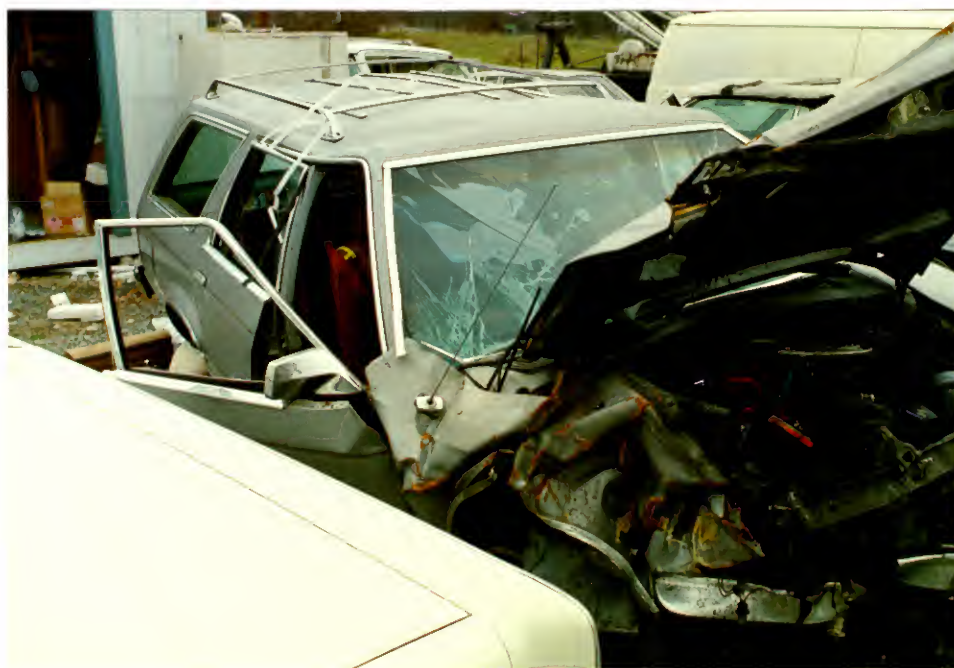
Left Side View of Vehicle #2.

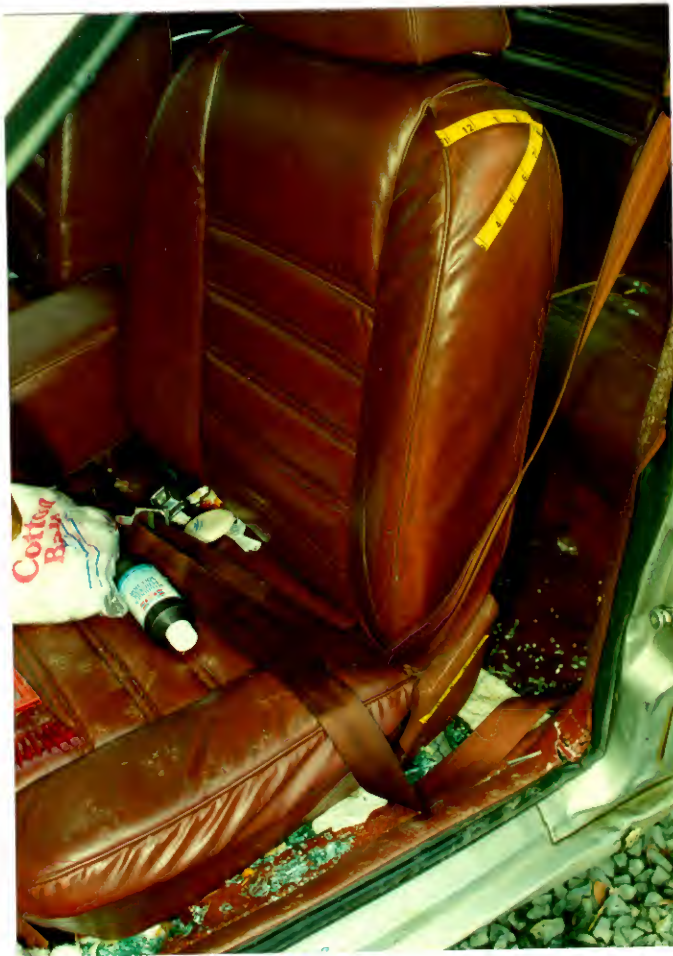
Overall Interior Views Of Driver #2's Trajectory And Contact.

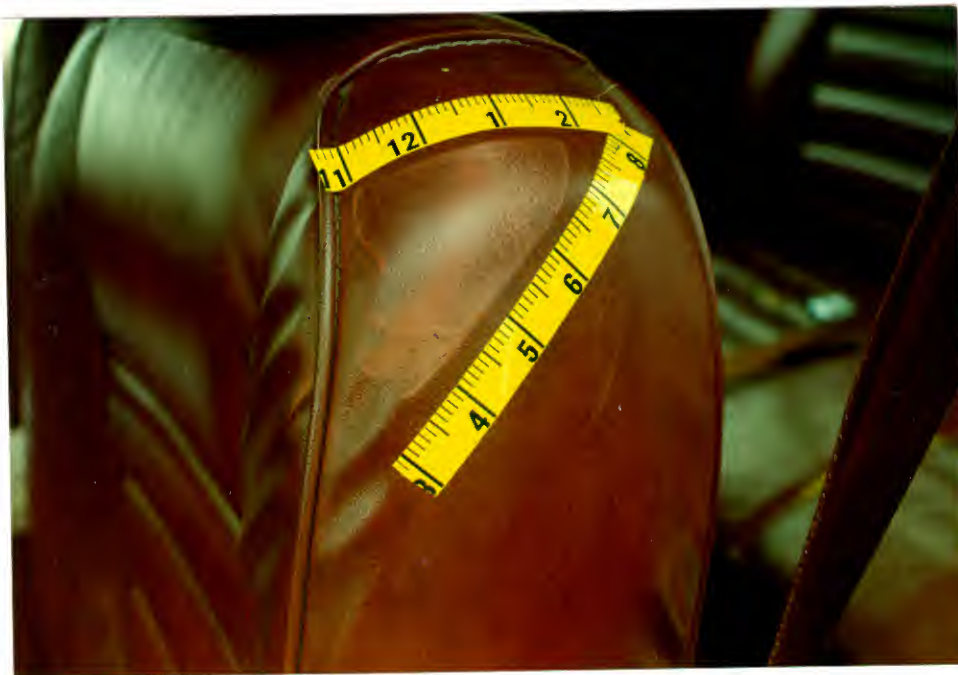
Driver's Seated Position And Active Belt System.

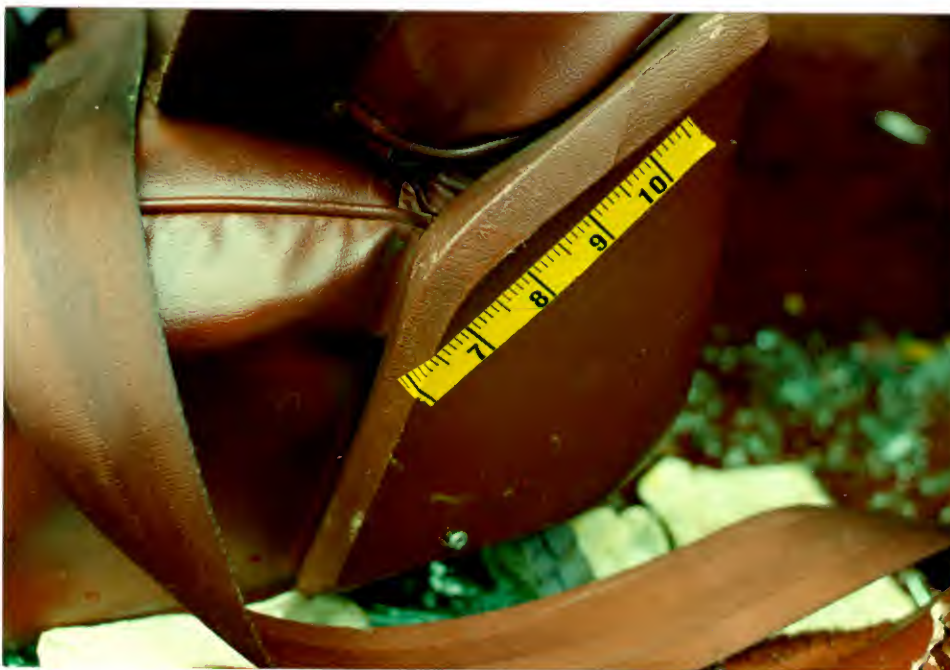
Shoulder Belt Abrasion To The Left Front Seatback.

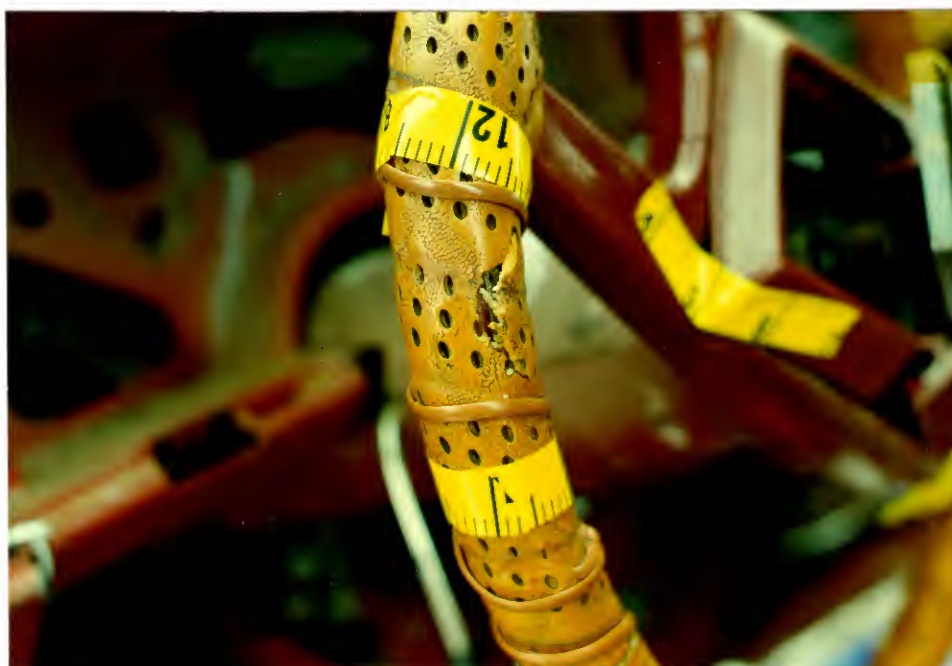
Lap Belt Abrasion To The Plastic Extrusion At The Seatback/Cushion Juncture.

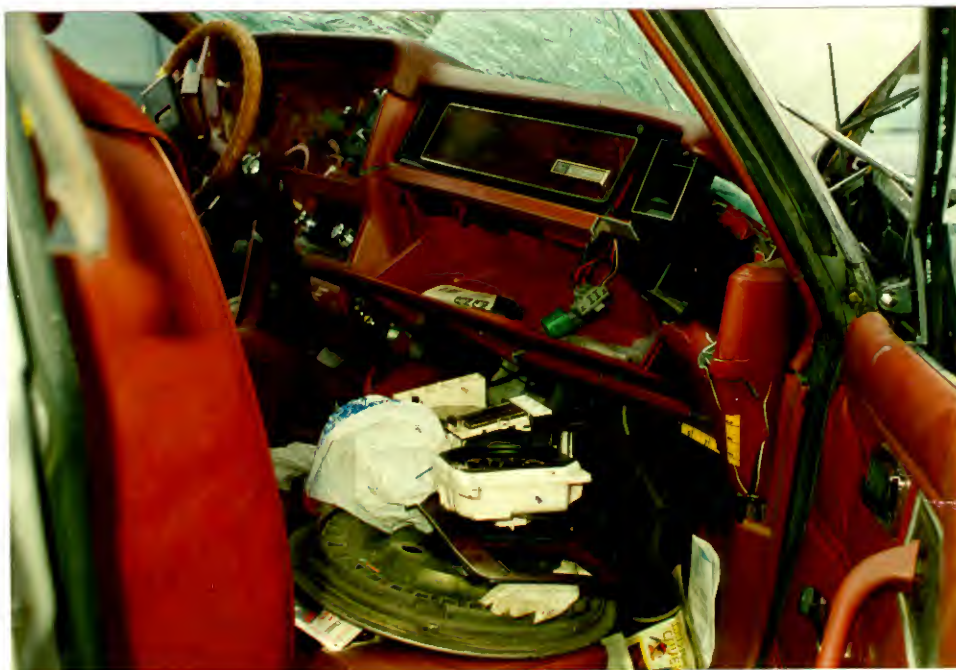
Mercury Zephyr's Steering Column Compression.
